**DEPARTMENT OF TRANSPORTATION**

Contract #: 04-0120F4Cty: SF/ALA Rte: 80 PM: 13.2/13.9File #: 69.28**WELDING INSPECTION REPORT****Resident Engineer:**Siegenthaler, Peter**Address:** 333 Burma Road**City:** Oakland, CA 94607**Report No:** WIR-021872**Date Inspected:** 10-Mar-2011**Project Name:** SAS Superstructure**OSM Arrival Time:** 700**Prime Contractor:** American Bridge/Fluor Enterprises, a JV**OSM Departure Time:** 1900**Contractor:** Zhenhua Port Machinery Company, Ltd (ZPMC), Changxing Island **Location:** Shanghai, China**CWI Name:** Mr. Xu Le Feng.**CWI Present:** Yes No**Inspected CWI report:** Yes No N/A**Rod Oven in Use:** Yes No N/A**Electrode to specification:** Yes No N/A**Weld Procedures Followed:** Yes No N/A**Qualified Welders:** Yes No N/A**Verified Joint Fit-up:** Yes No N/A**Approved Drawings:** Yes No N/A**Approved WPS:** Yes No N/A**Delayed / Cancelled:** Yes No N/A**Bridge No:** 34-0006**Component:** Tower and Orthotropic Box Girder (OBG)**Summary of Items Observed:**

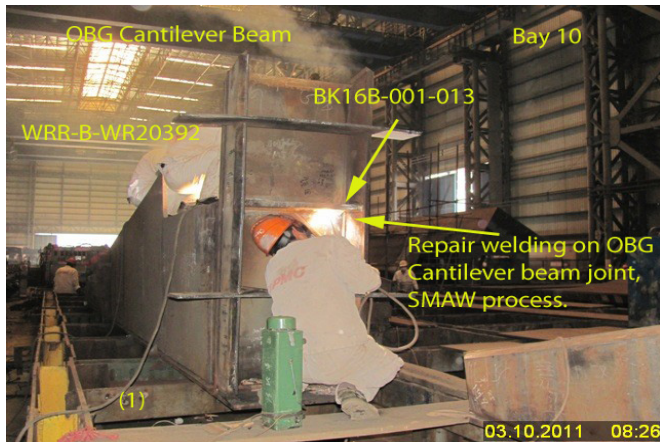
This QA Inspector observed ZPMC qualified welding personnel identified as 057220 Perform Shielded Metal Arc Welding (SMAW) on OBG Cantilever beam. Joint identified as BK16B-001-013. ZPMC QC Identified as Yan Chang Fang with temporary welding repair report WRR-B-WR20392. The welding parameters as measured using QC's calibrated instrument appeared to be in general compliance with WPS-345-SMAW-4G (4F) Repair. For more information see attached picture number 1.

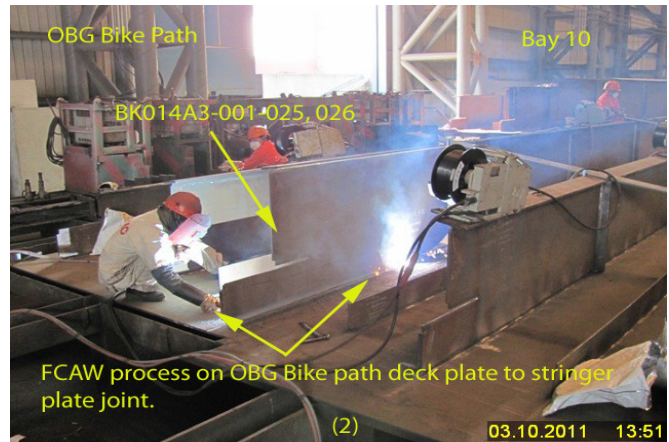
This QA Inspector observed ZPMC qualified welding personnel identified as 040302, 053869 Perform Flux Core Arc Welding (FCAW) on OBG Bike path. Joint identified as BK014A3-001-025, 026. ZPMC QC Identified as Lijun. The welding parameters as measured using QC's calibrated instrument appeared to be in general compliance with WPS-B-T-2132-ESAB. For more information see attached picture number 2.
